NATIONAL TRANSPORTATION SAFETY BOARD

RAILROAD ACCIDENT REPORT

SIDE COLLISION OF
TWO MISSOURI PACIFIC RAILROAD COMPANY
FREIGHT TRAINS
AT GLAISE JUNCTION,
NEAR POSSUM GRAPE, ARKANSAS
OCTOBER 3, 1982

NTSB/RAR-83/06

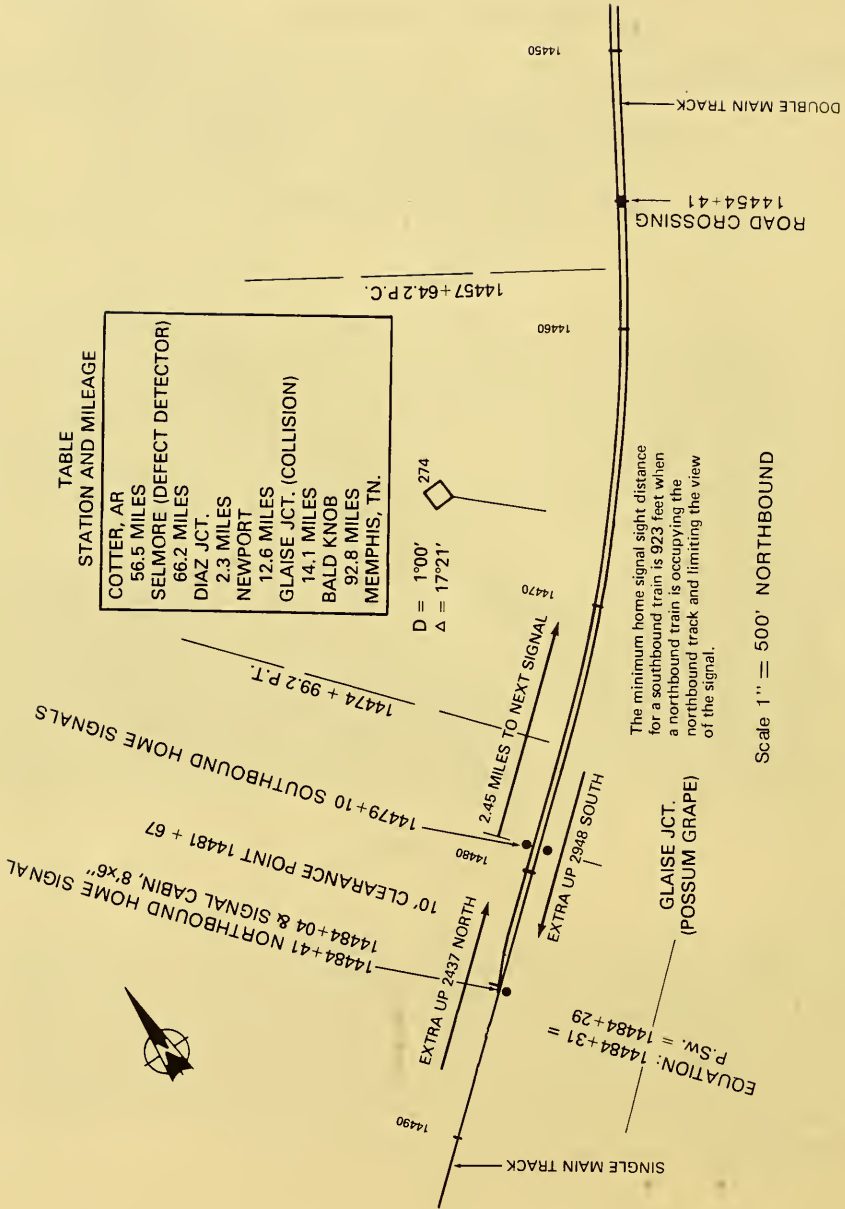
Figure 1.--Plan view of track at accident site.

initial terminal air brake test and was operated to Glaise Junction, Arkansas, a distance of 107 miles, without incident. The engineer was seated at the controls of the lead locomotive unit, and the fireman and head brakeman were seated in their respective positions on the left side of the same cab as the train approached Glaise Junction. The conductor and rear brakeman were in the caboose. About 4:13 a.m., as Extra UP 2437 North approached the Glaise Junction switch, the train dispatcher aligned the remotely controlled switch and signal to enable Extra UP 2437 North to exit the single main track and enter onto the west track of the two-track system north of that location. (See drawing, figure 1.)

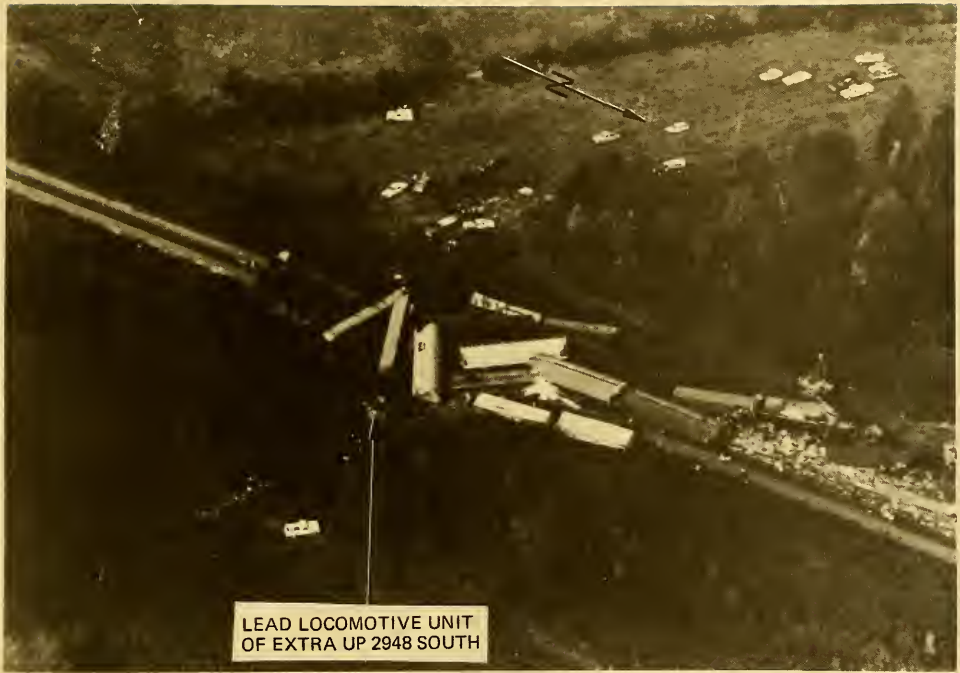
Figure 2.—Overview of collision/derailment site.

Trains.--The cab of the lead locomotive unit of Extra 2948 South was severely deformed during the collision and was deformed further as it rolled down the embankment on the east side of the fill supporting the track. Fuel oil leaked from the overturned unit's damaged fuel supply tanks and was ignited. The other locomotive units and nine following freight cars were damaged heavily. Damage to the train was estimated to be \$646,000. The eighth car from the rear and the following six cars in Extra UP 2437 North were damaged heavily as a result of the collision. The caboose and the car immediately ahead were not damaged. Damage to the train was estimated to be \$131,000. The combined loss of lading for both trains amounted to \$165,000.
